## Deburring tool solves engine problem

**F**ord Motor Co. of Australia Ltd. realized some of its engines were showing reduced performance. At its production plant in Geelong, the automaker traced the problem to burrs and drill caps at the intersections of cross-drilled holes in camshafts.

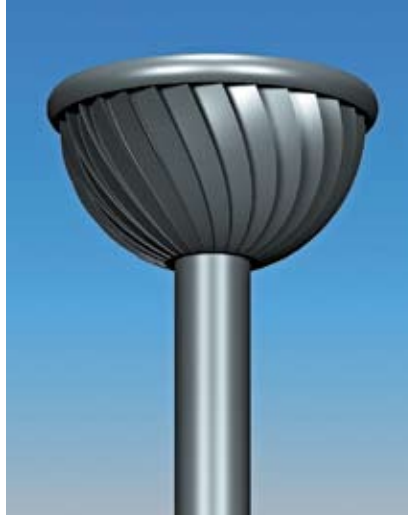
**The Orbitool permits Ford Australia to perform in-process removal of burrs and drill caps from the intersections of cross-drilled holes in camshafts. Previously, the burrs and drill caps were hurting engine performance when they would break off and jam the cam timing system.**

The automaker turned to Okuma Australia Pty. Ltd., Rowville, for suggestions. The machine tool builder's solution consisted of a machining center installed next to the camshaft production line. The system applies Orbitool deburring tools from J.W. Done Corp., Hayward, Calif. The Orbitool permits in-process deburring of holes immediately after they've been drilled.

However, for the Orbitool to work as designed, the drill can't become too worn because the burrs and drill caps will become too large for the Orbitool to remove in the process time allowed.
